# Navigating the Depths: An Assessment of the Management and Operations of Alau Dam Reservoir

Mala Babagana Gutti<sup>1\*</sup>, Jibril Alhaji Yunusa<sup>2</sup>, Umar Busuma<sup>3</sup>, Sadiq Abdullahi Wazir<sup>4</sup>

<sup>1,2,3,4</sup>Department of Civil and Water Resources Engineering, University of Maiduguri, Maiduguri, Nigeria.

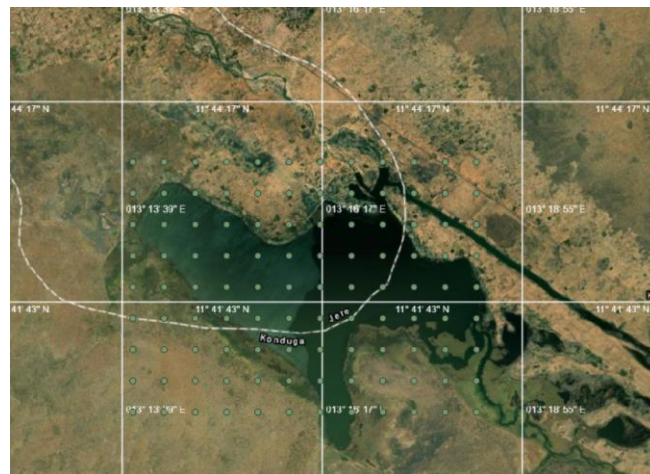
Figure 3b: Satellite imagery showing Alau reservoir.

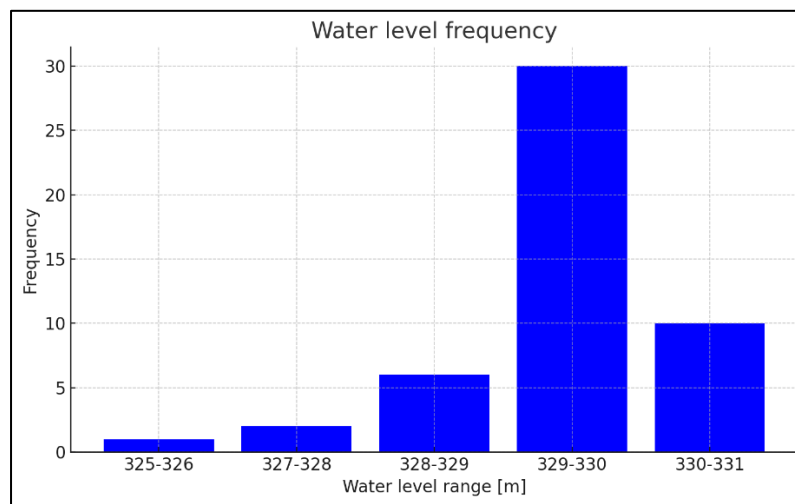
Operational practices at the Alau Dam contribute significantly to its inability to manage water levels effectively. The scheme follows a management approach where the spillway sluice gates are opened only once annually, typically when the water level reaches 329 meters above mean sea level (MSL) in August or September and remain open for a prolonged three-month period. This operational strategy does not provide the necessary flexibility to manage the reservoir's water levels throughout the year effectively. Inconsistent release schedules have led to both overflows and flood events downstream, particularly impacting the communities along the Ngadda River. The analysis of operational records and historical water level data (Figure 4) indicates that the water level fluctuates between 329m and 330m throughout the spilling months, indicating poor planning and delayed water releases as these levels are already above the free zone of the dam. This lack of an effective forecasting and planning further compounds the issue, leaving the dam vulnerable to unexpected overtopping and flooding during peak inflow periods.

Figure 4: Frequency of flow release from Dam.

- 1. Flexible Water Release Policy:** The current frequency and timing of water release from the Alau Dam reservoir contribute significantly to downstream flooding. It is crucial to develop a comprehensive water release policy informed by hydrological and hydraulic modelling. This policy should ensure controlled and regulated water releases that consider the downstream river capacity and ecological factors, thereby minimizing flood risks and promoting environmental sustainability.

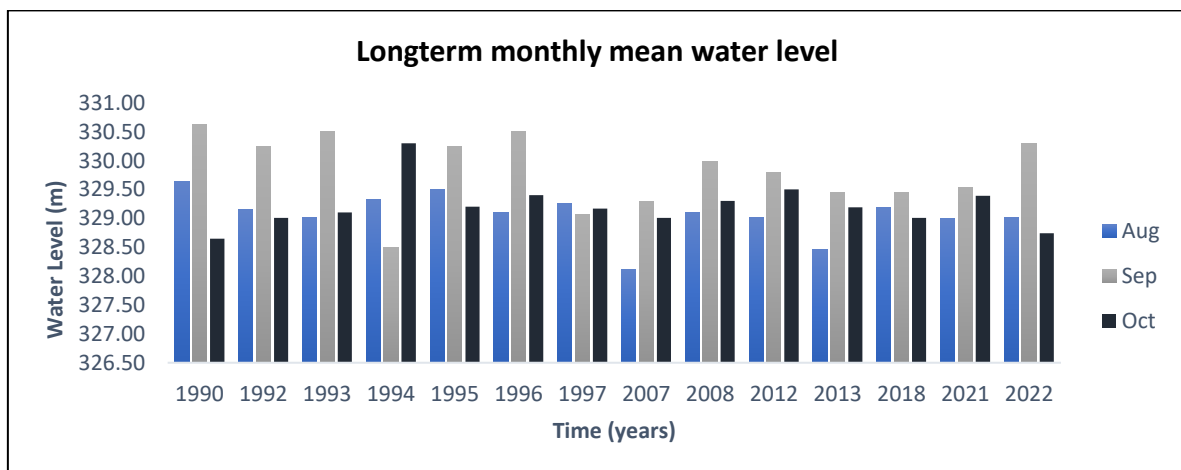
From long-term water level data (Figure 5), it is evident that the Alau Dam reservoir consistently reaches peak water levels in August and September, likely due to a combination of reduced demand for water during these months and the reservoir's seasonal recharge. The historical analysis also shows that the peak water levels over the last 30 years have consistently been in September, a trend that should have allowed dam operators to predict and manage water releases more effectively. However, poor operational planning has resulted in frequent flooding. The data indicates that floods continue to affect downstream communities, despite decades of operational records that could have informed better management practices. This reinforces the notion that inadequate planning, rather than lack of information, is responsible for the dam's hydraulic failures over the years.

Figure 5: Peak months of water level of Alau reservoir

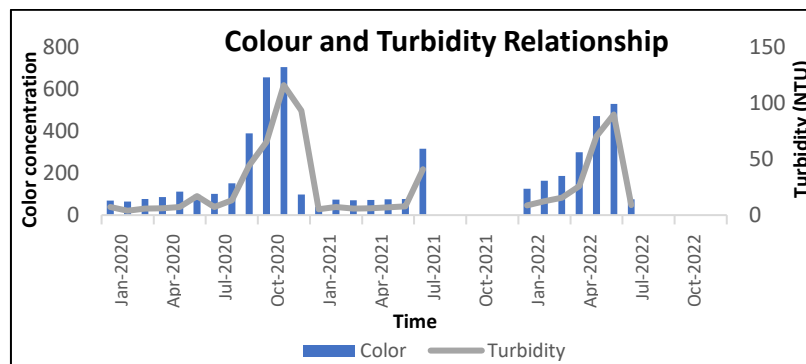
The quality of water within the Alau Dam reservoir was found to be moderately acceptable, with pH levels generally ranging between 7.0 and 8.0, indicating neutral to slightly alkaline conditions. However, there were occasional deviations with low pH values between 0.5 and 4.0 (Figure 6), which point to potential pollution events, possibly linked to agricultural runoff and other economic activities upstream. Turbidity levels (Figure 7) and colour concentrations indicated moderate pollution, primarily from suspended matter and other contaminants introduced through upstream agricultural activities, including waste from small-scale farms and brick moulding enterprises (Figures 8a and 8b). Additionally, unsustainable fishing practices were noted during field visits, despite existing policies aimed at conservation (Figures 8c and 8d). Enforcement of these policies was found to be weak, with little effort to ensure sustainable land use and fishing practices around the reservoir. Moreover, the dam's operational model does not consider environmental flows, leading to significant downstream ecological degradation as discharge from the dam is solely regulated by water level management and flood control needs.

Figure 6: Colour and Turbidity in Reservoir

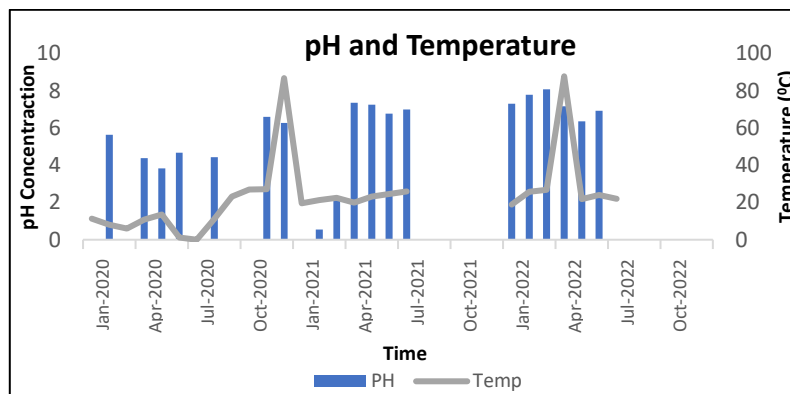
Figure 7: pH and Temperature of Water in Reservoir

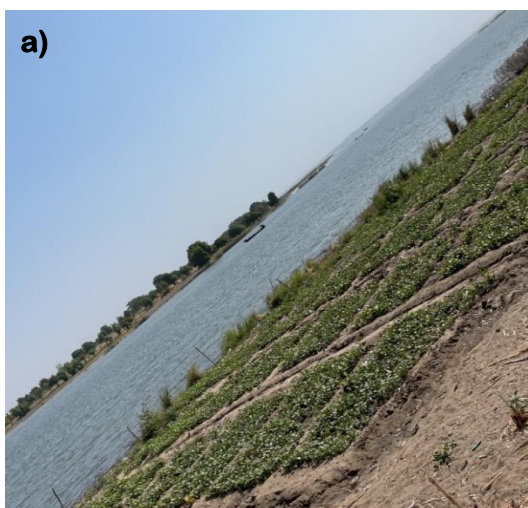
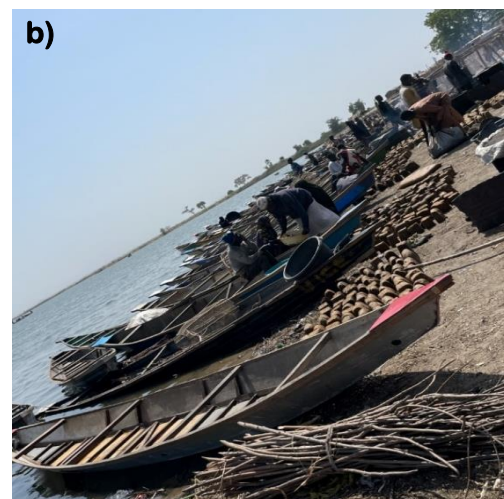
**Figure 8: a) Small scale farming, b) Bricks making and fish smoking activities, c) Small scale continuous fishing practices, d) Large scale continuous fishing practices.**
